PILOT BOARDING DEFICIENCY REPORT

DATE: 11/17/20 TIME: 2100

VESSEL: Maersk Kensington

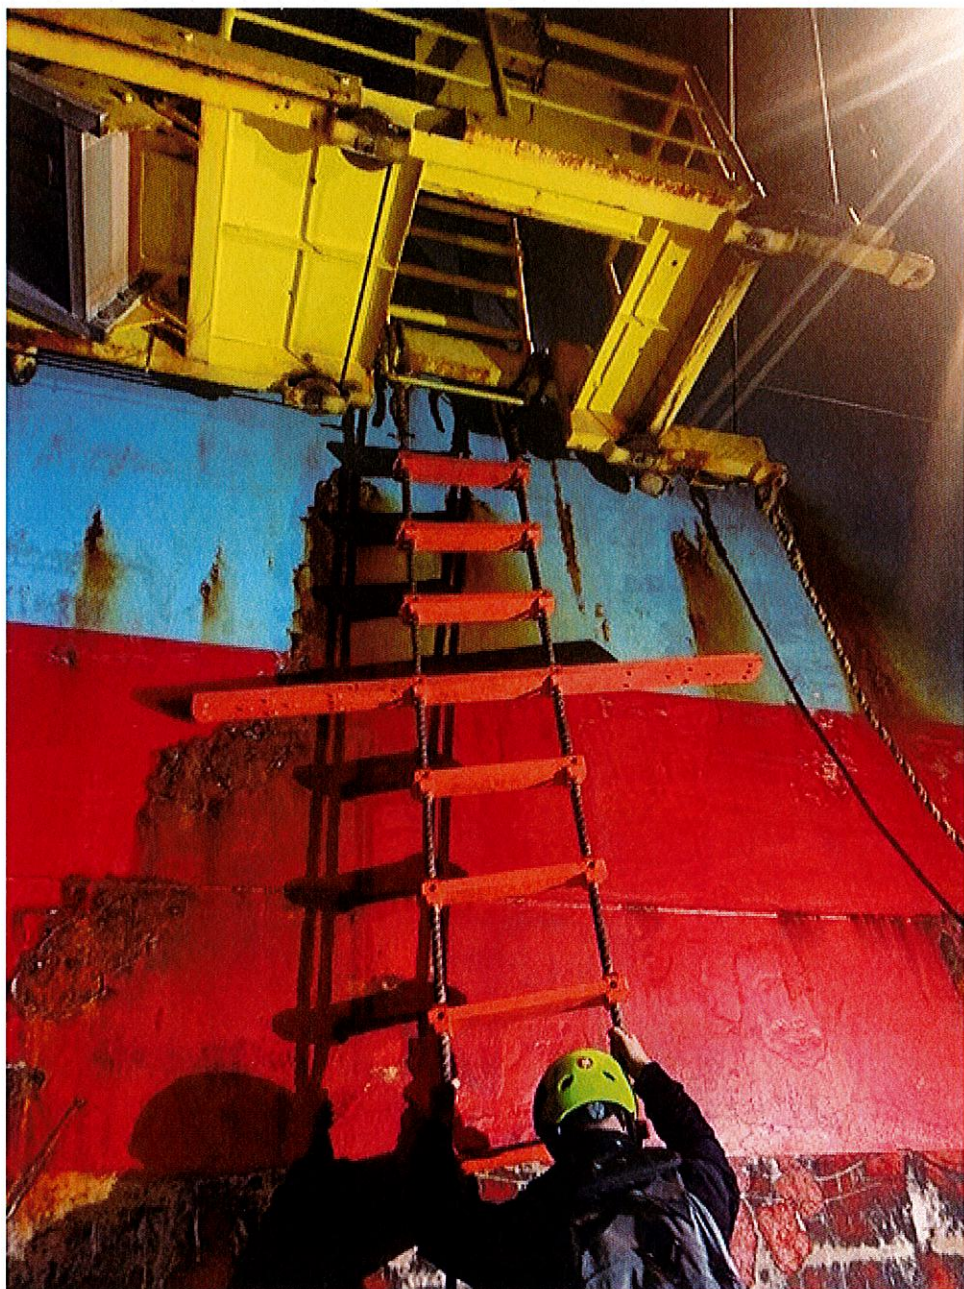
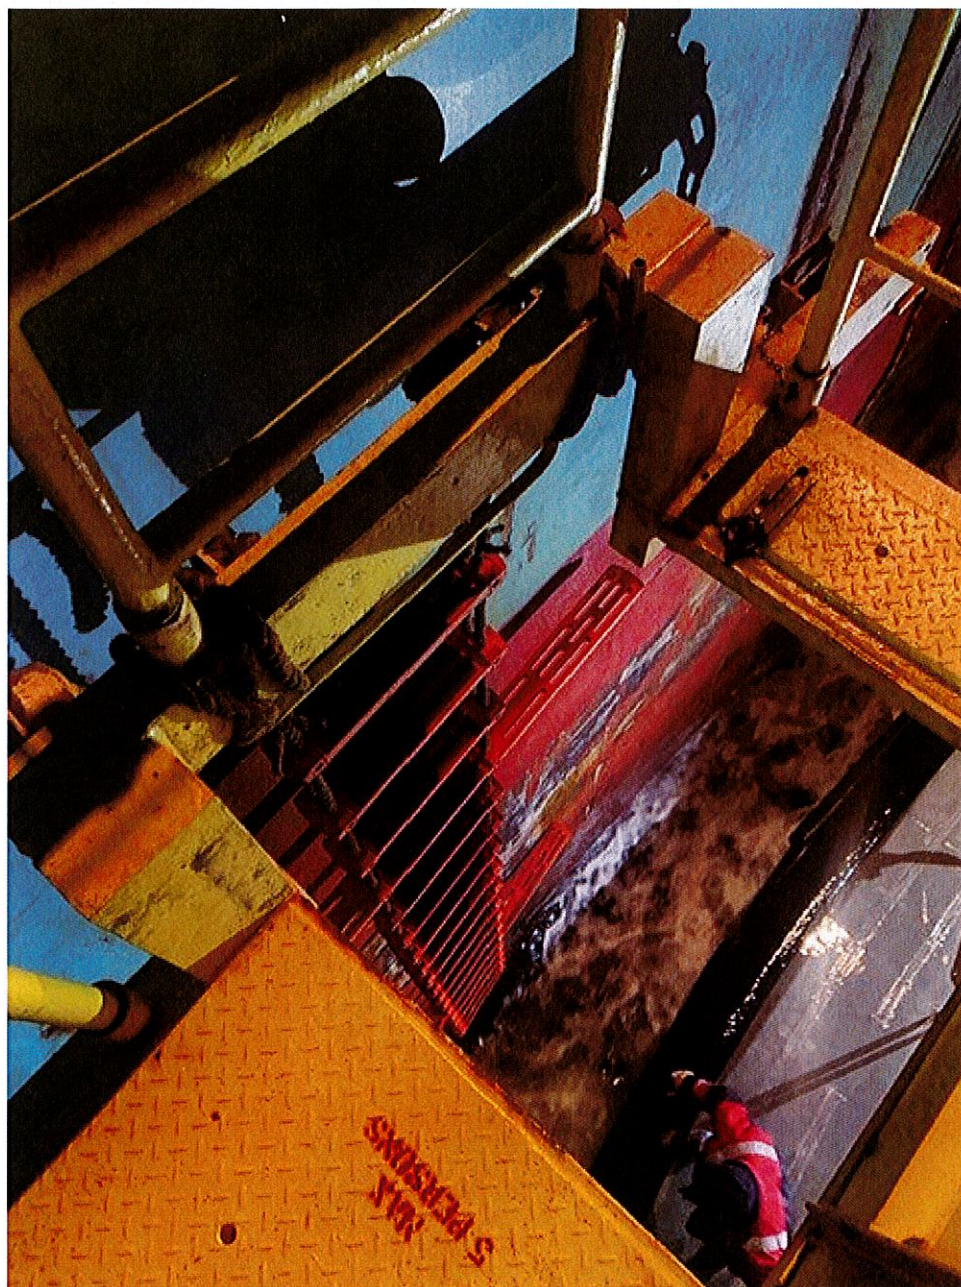
Ladder not flush with side of ship; ladder not properly secured to gangway

Trapdoor ladder arrangement - rope ladder not vertically in line with upper metal handholds

The transfer from the gangway through the trapdoor onto the the ladder is unsafe. The trapdoor arrangement does not allow the ladder to sit flush with the side of the ship and also forces the pilot to climb down from one vertical plane to another as he descends the ladder.
