PILOT BOARDING DEFICIENCY REPORT

DATE: 6/6/2021 TIME: 2100

VESSEL: Gunde Maersk

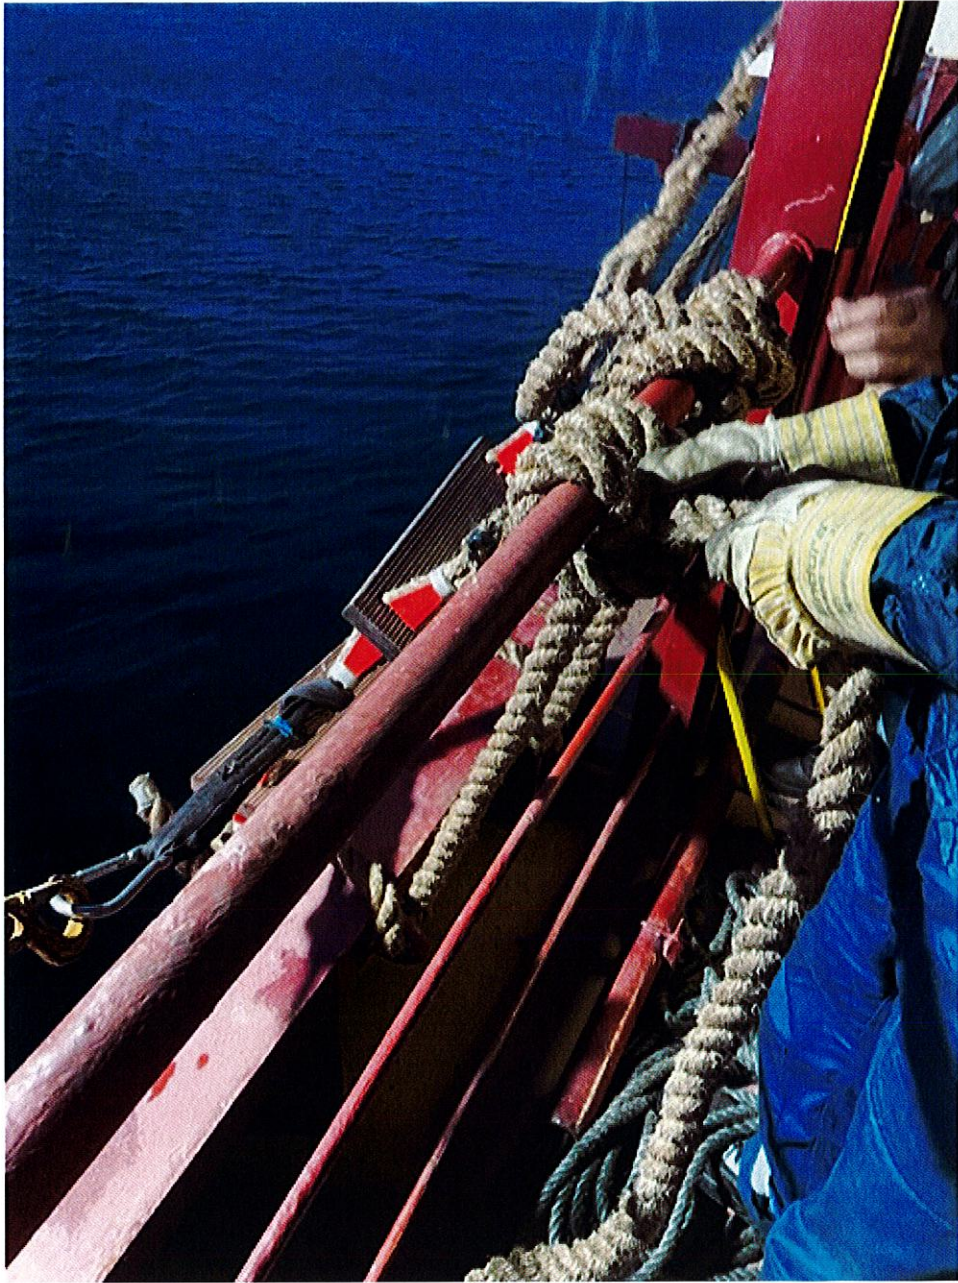
Ladder not properly secured

Vessel deeply laden. Ladder had to be moved aft of reel to accommodate combination configuration

Ladder was improperly secured to handrail. No "strongpoint on deck" available to properly secure
