PILOT BOARDING DEFICIENCY REPORT

DATE: 1/20/21 TIME: 2030
VESSEL: MAERSK DENVER
MASTER: N/A
PILOT: 035 JSP
CONDITIONS: NW'LY 20KTS

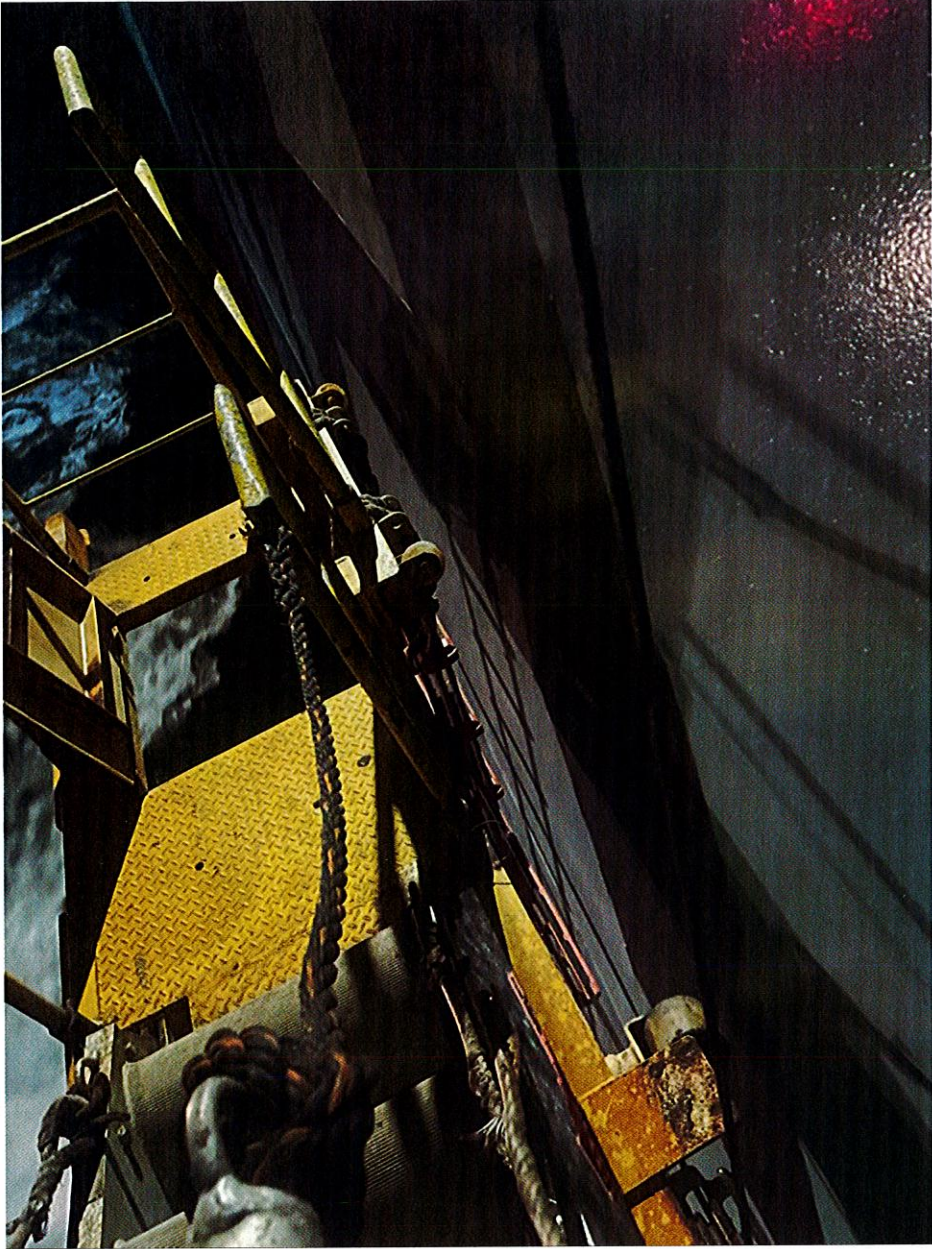
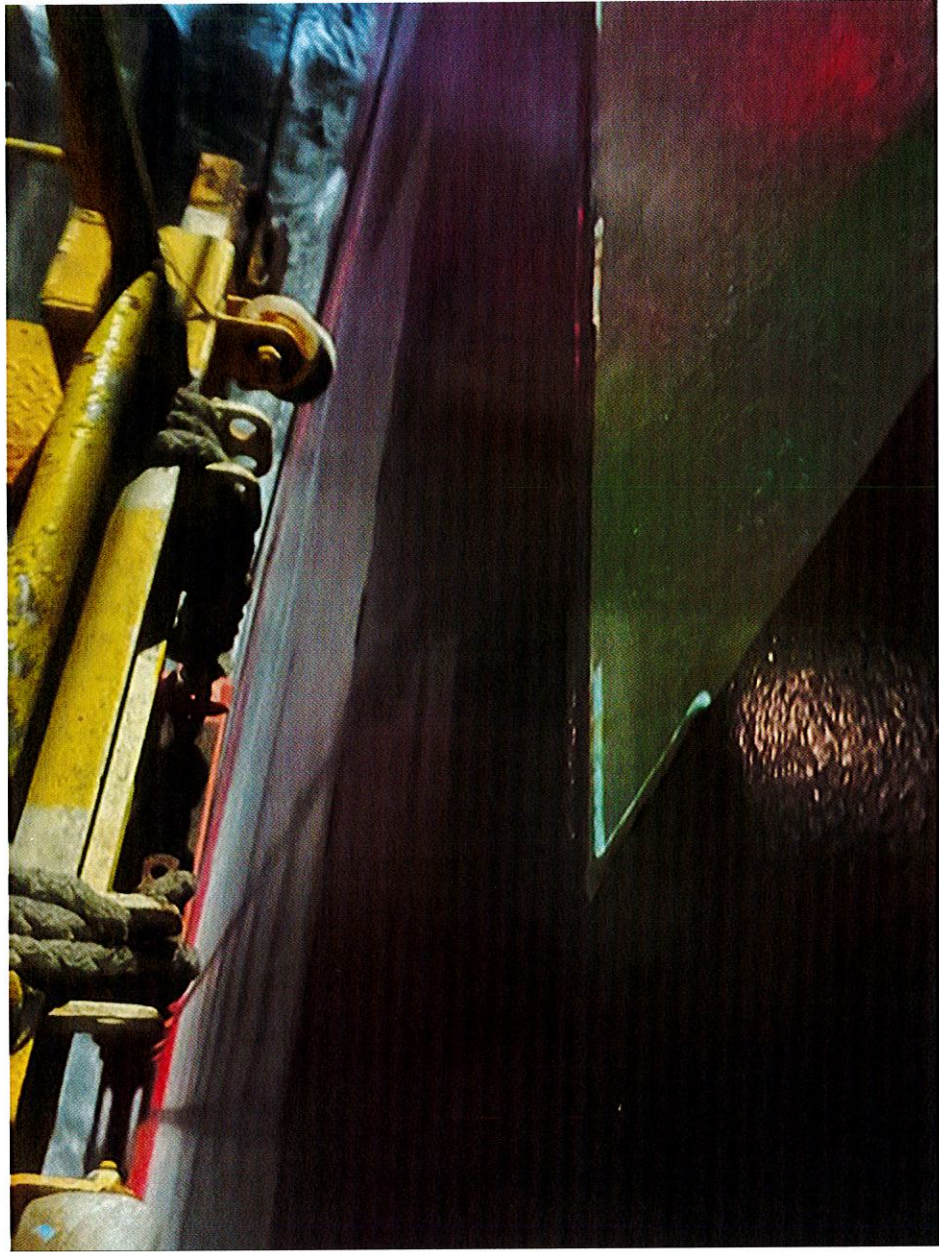
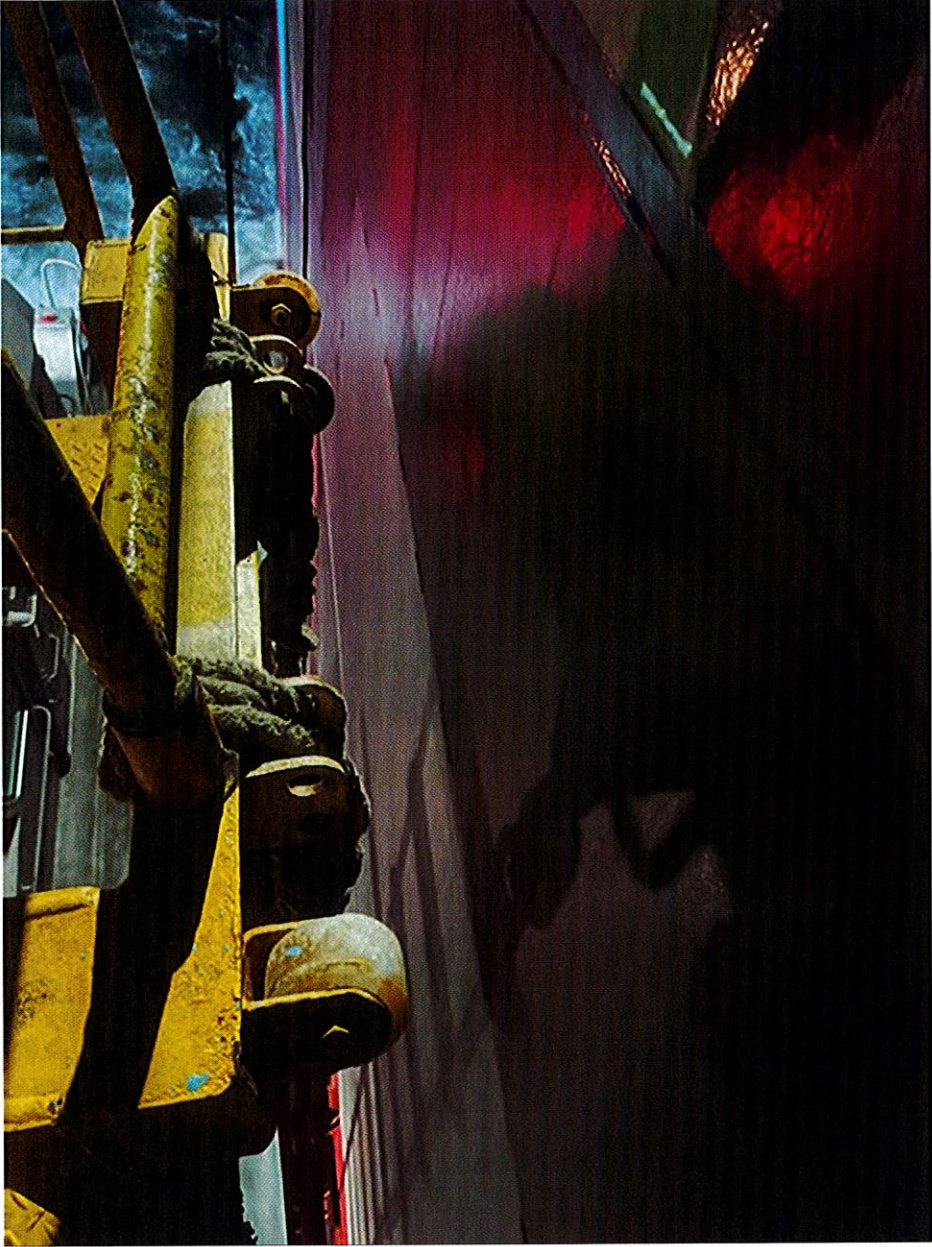
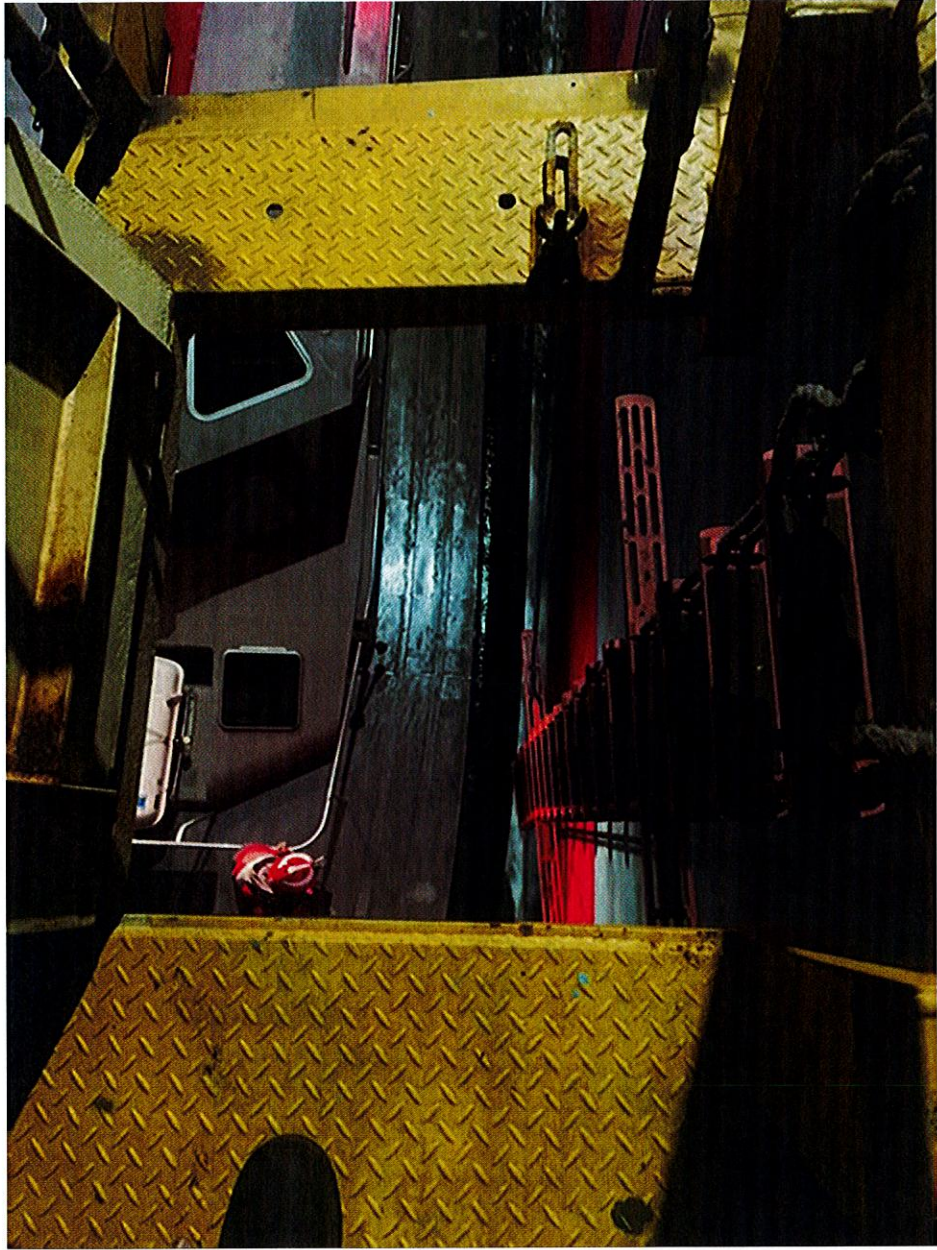
CHAFFED DWD POOR RUNG CONDITION, NOT

RESTING ON THE HULL AT ALL.

THE LADDER ON THE MAERSK DENVER IS ONE OF THE WORST DISPLAYS OF SAFETY AND SEAMANSHIP I HAVE ENCOUNTERED IN REARDS TO PILOT LADDER

AND PILOT BOARDING ARRANGEMENTS. THE OVER-ALL CONDITION OF THE LADDER WAS IN A STATE OF DIS REPAIR AS I DESCENDED THE MAIN PORTION OF THE TRAP DOOR COMBINATION TO THE PLATFORM I NOTICED THAT THE WHOLE GANGWAY WAS RACKED (i.e. TWISTED AND FALLING AWAY FROM THE HULL.) THE TRANSITION LADDER TO JACOBS LADDER PORTION WAS A VERY FAR STRETCH AND THE METAL PORTION WAS BENT BACKWARD AWAY FROM THE HULL. FINALLY AT NO POINT DID THE ENTIRE COMBINATION TRAP DOOR REST ON THE HULL ~ i.e. ~ THE ENTIRE LADDER WAS SWINGING WITH THE SEOWAY AND A STRAIGHT FREE CLIMB WITH NO SUPPORT FOR 7 METERS TO THE DECK!!
