PILOT BOARDING DEFICIENCY REPORT

DATE: 2/25/21 TIME: 2200

VESSEL: FSL SINGAPORE

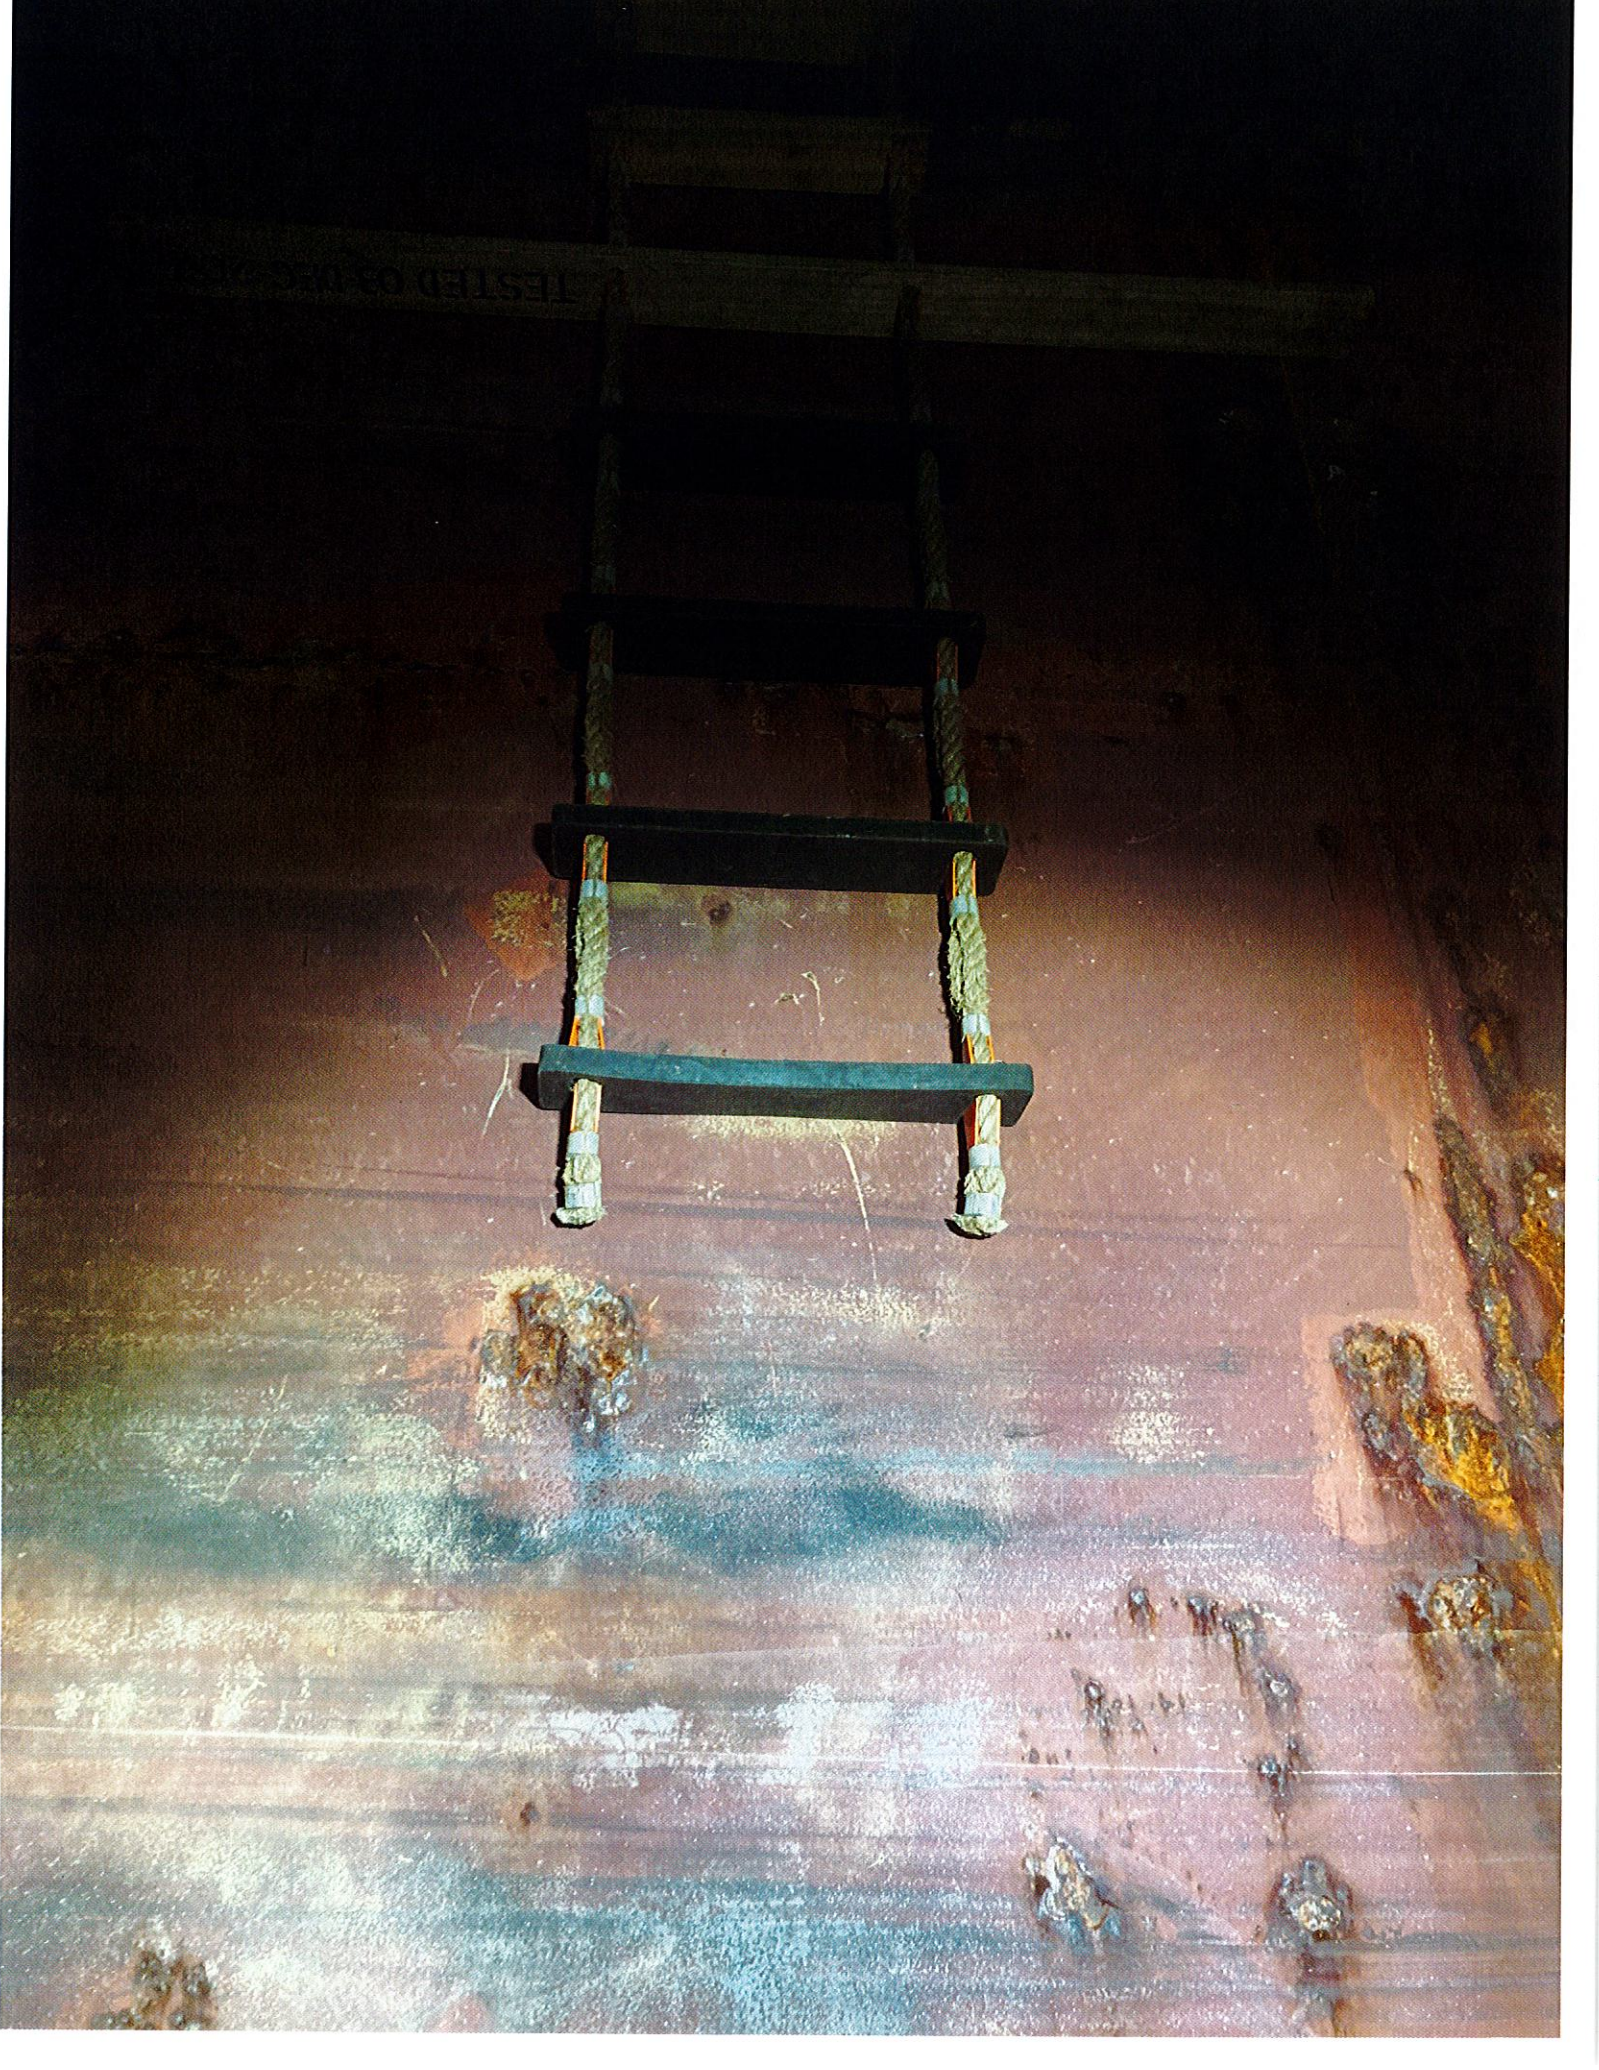
SIDE ROPES SEEM TO BE TWO PIECES + NOT ONE ROPE

IMO STATES SIDE ROPES SHOULD BE CONTINUOUS WITH NO JOINTS. SEE THE ATTACH PICTURE BOTTOM STEP HAS A JOINT WHICH APPEARS SIDE ROPES ARE MADE OF TWO ~~PART~~ PIECES OF ROPE
